# Evaluating the effects of agricultural drainage ditches on water levels in Wisconsin's central sands

Steve Sellwood

UW – Madison Department of Geoscience  
Wisconsin Geological and Natural History Survey

March 5, 2015

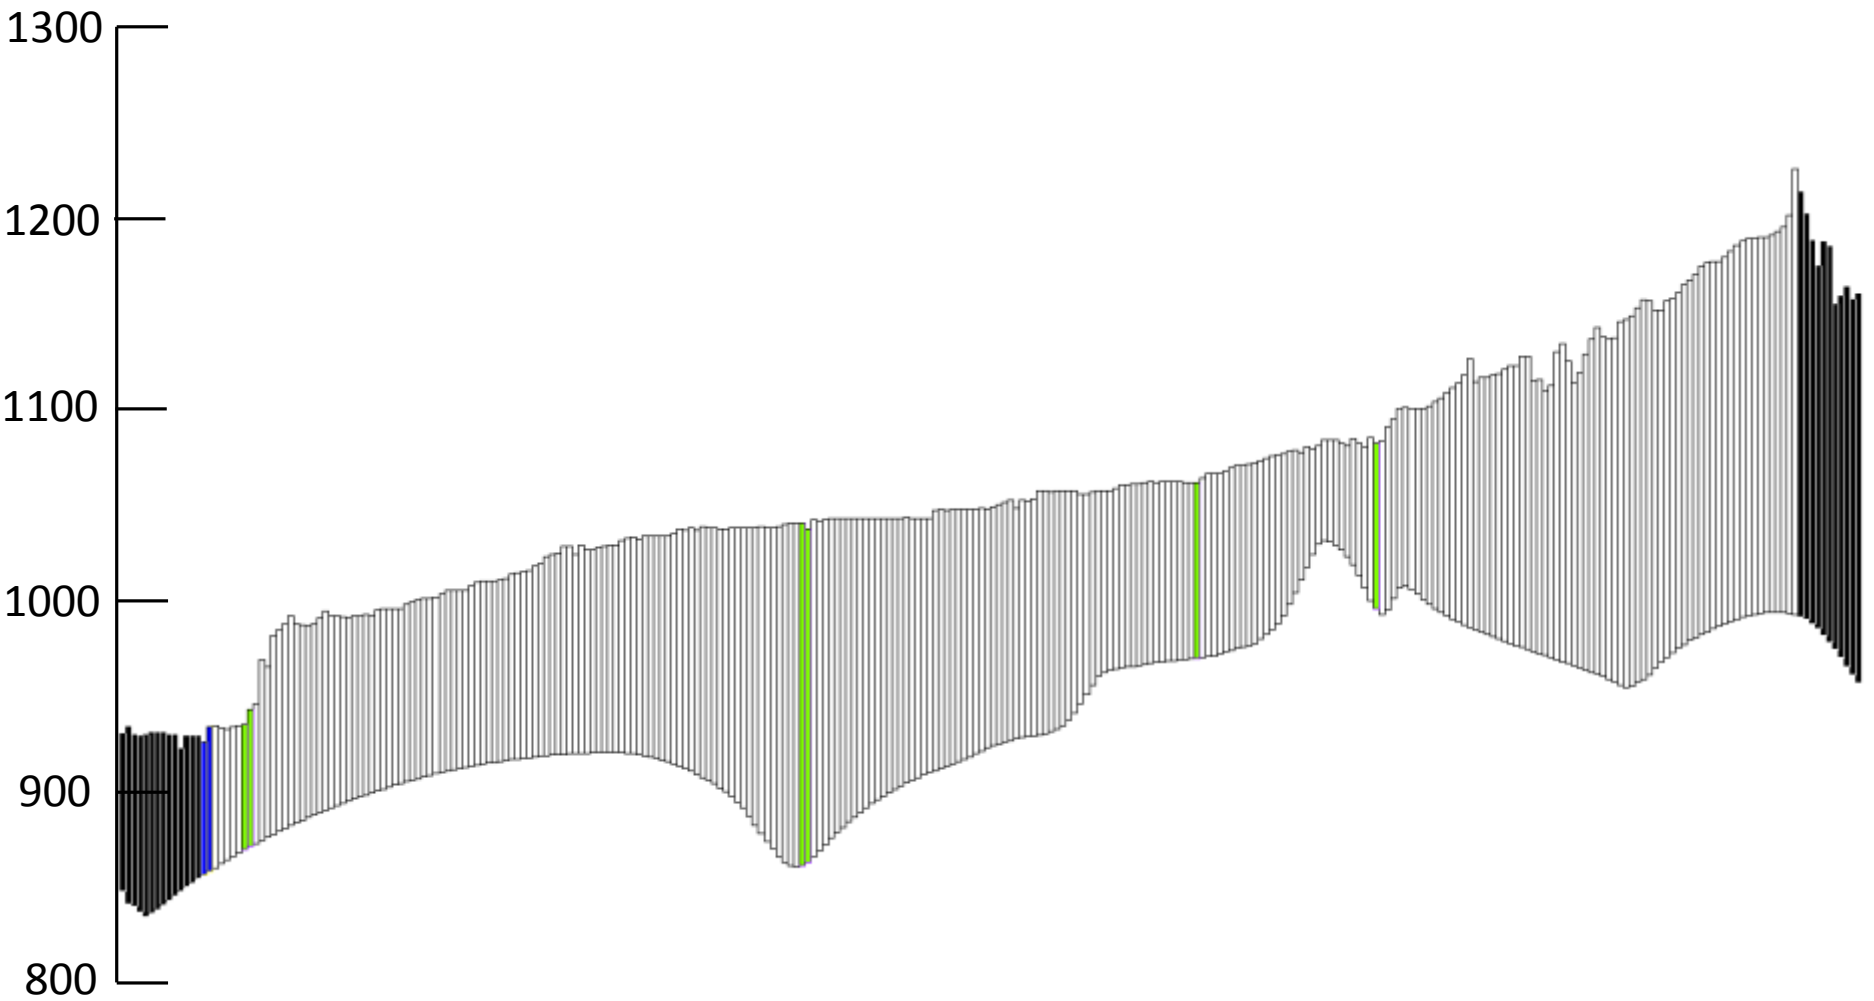
Elevation  
(ft amsl)

Vertical exaggeration = 170:1

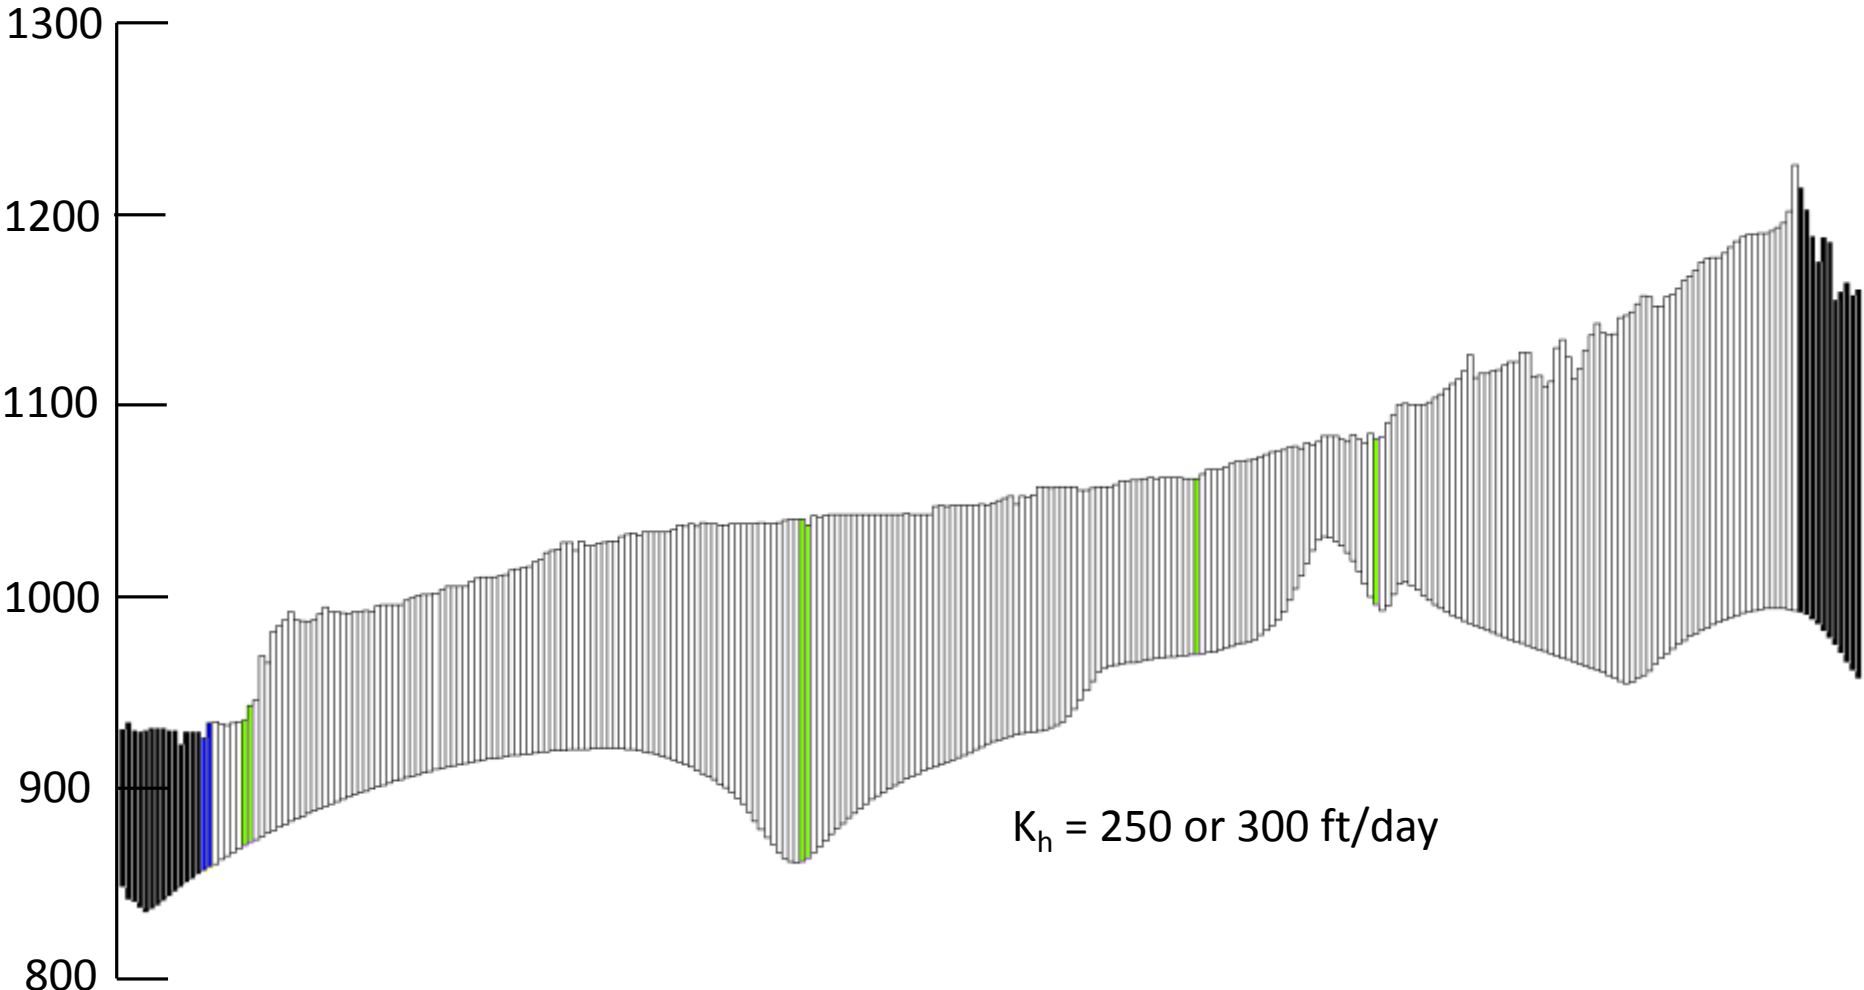
$K_h = 250$  or  $300$  ft/day

Elevation  
(ft amsl)

Vertical exaggeration = 170:1

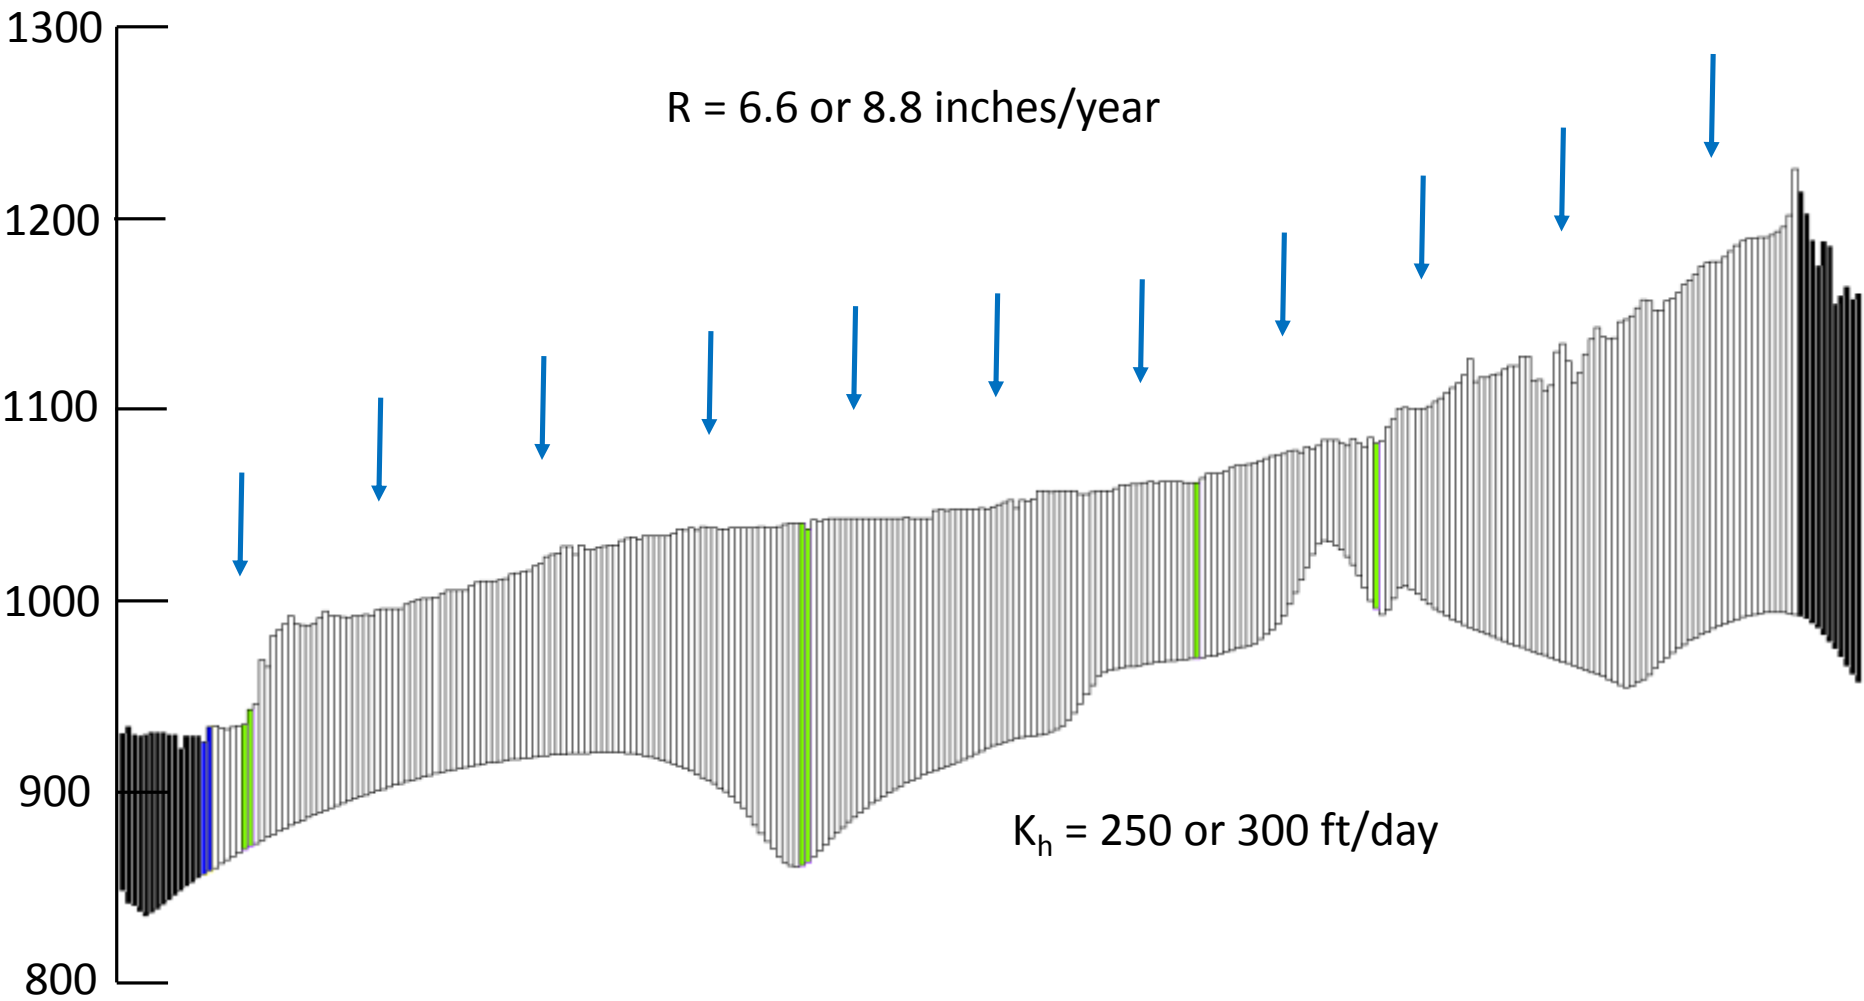
$R = 6.6$  or  $8.8$  inches/year

$K_h = 250$  or  $300$  ft/day

Vertical exaggeration = 170:1

Elevation  
(ft amsl)
